PROPERTY DATA

Property address: **Your Address**
City: **London**
Postal code: **SW1A 0AA**
Country: **UK**
Building type: **Office**

Client: **Your Company Ltd**
Inspection date: **01.01.2025**
Report number: **UK1234**

Report issuer: **Inotek Analysis**
Engineer: **Fredrik Rist**
Email: **fredrik@inotek.no**

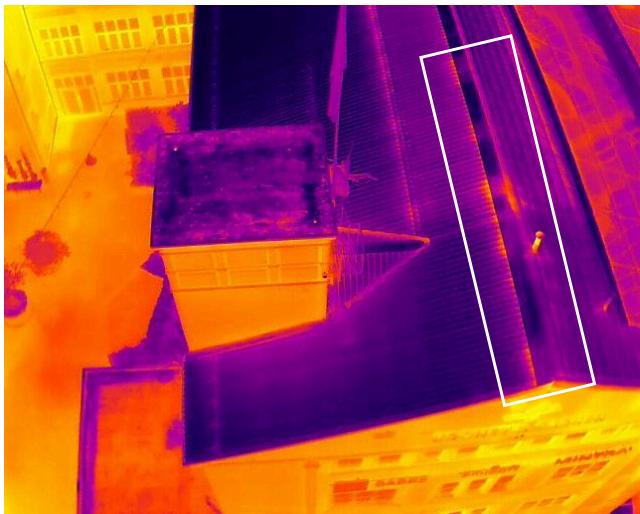
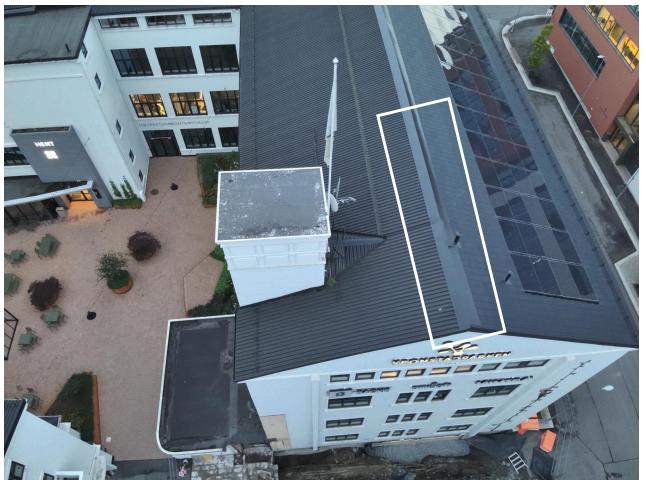
Deviation 001 – Roof

RPL 3

Heat loss has been identified in the marked thermogram, indicating a thermal anomaly in the roof section. This suggests the presence of a thermal bridge, where heat is escaping through areas of insufficient insulation. The observable evidence from the thermogram highlights the specific locations where the temperature differential is significant. The extent of the issue appears to be localized, but it may have implications for overall energy efficiency and comfort within the building. The affected areas should be closely monitored for further signs of heat loss or moisture intrusion. Visual inspection may reveal additional clues regarding the integrity of the insulation in these regions.

The most likely cause of the heat loss is inadequate insulation at the thermal bridge locations. This can lead to increased energy consumption and potential discomfort for occupants. If left unaddressed, it may also result in moisture problems, which could compromise the building's structural integrity over time.

kWh: 390 CO₂ (kg): 48.3

Improve insulation in the identified areas to mitigate heat loss. Conduct regular inspections to ensure the effectiveness of the insulation. Consider implementing preventative measures to avoid future thermal bridging.

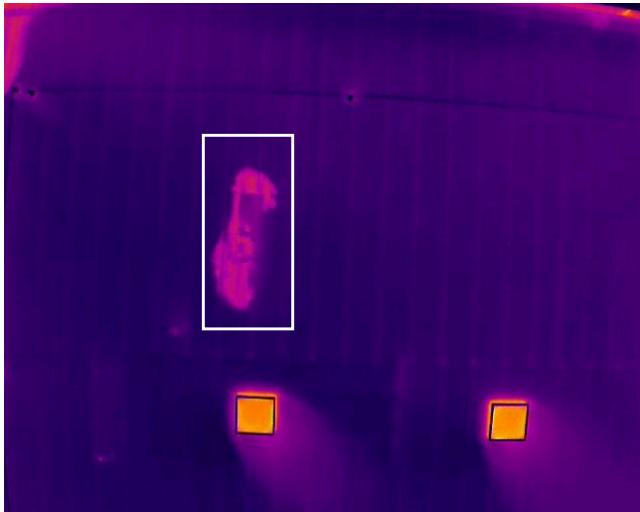
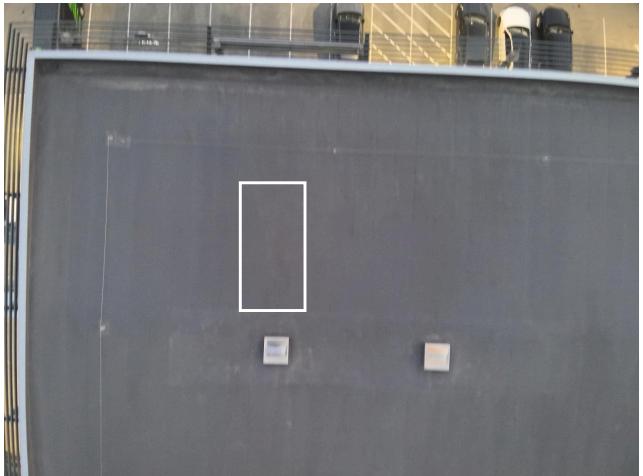
Deviation 002 – Roof

RPL 3

Significant moisture accumulation has been detected beneath the roofing membrane, as evidenced by the attached thermal image. The affected area is located on the roof, where the insulation is likely compromised due to the presence of water. This condition poses a risk of further damage to the roofing structure and insulation materials. The extent of the moisture accumulation suggests a prolonged exposure to water, which could lead to mold growth and deterioration of building materials. Immediate attention is required to assess the full impact of this moisture intrusion.

The most likely cause of the moisture accumulation is a breach in the roofing membrane, allowing water infiltration. This can lead to significant risks, including structural damage, insulation failure, and potential health hazards due to mold growth. The uncertainty surrounding the extent of the damage necessitates a thorough investigation.

kWh: 412 CO₂ (kg): 82

Remove the wet insulation to prevent further damage. Repair the hole in the roofing membrane to stop water infiltration. Implement regular inspections to prevent future occurrences.

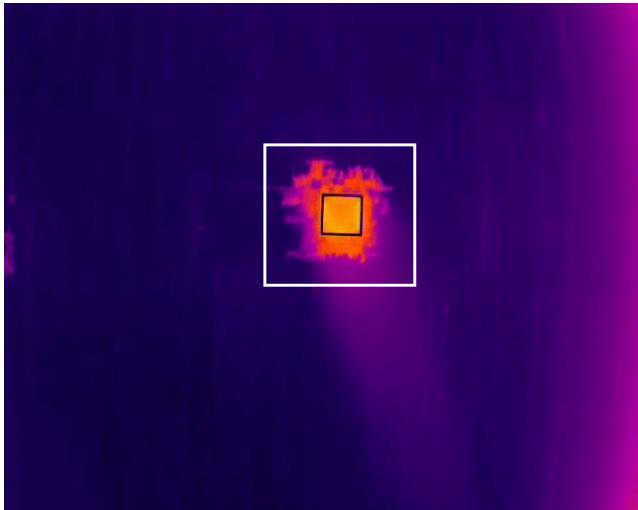
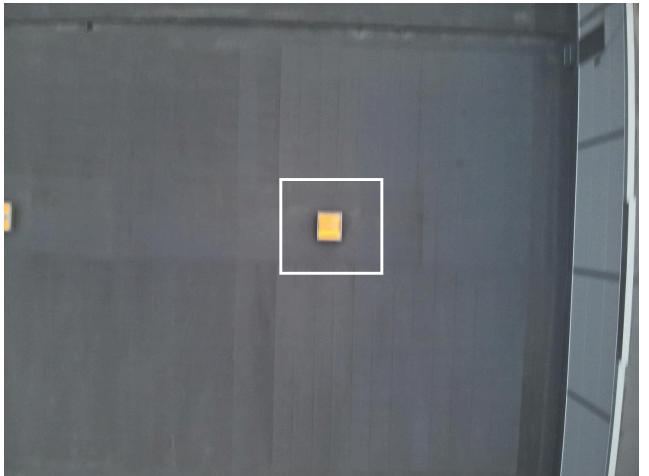
Deviation 003 – Roof

RPL 3

There are significant challenges with condensation within the roof structure, as evidenced by the thermal imaging results. The issue is not visually apparent but is indicated by the thermal anomalies detected. Poor insulation around the skylight has been identified as a contributing factor to the condensation problem. The affected area includes the roof membrane and surrounding insulation, which may be compromised due to moisture accumulation. This situation suggests a potential risk of further damage to the roofing system if not addressed promptly. The extent of the problem requires careful evaluation to determine the full impact on the structural integrity of the roof.

The primary cause of the condensation is likely inadequate insulation around the skylight, leading to temperature differentials that promote moisture accumulation. If left unaddressed, this could result in mold growth, deterioration of building materials, and potential structural damage over time. The uncertainty lies in the extent of moisture penetration and its long-term effects on the roof structure.

kWh: 390 CO₂ (kg): 78

Remove the wet insulation and repair the affected areas. Re-roof the membrane to ensure proper sealing and insulation. Implement measures to improve insulation around the skylight.

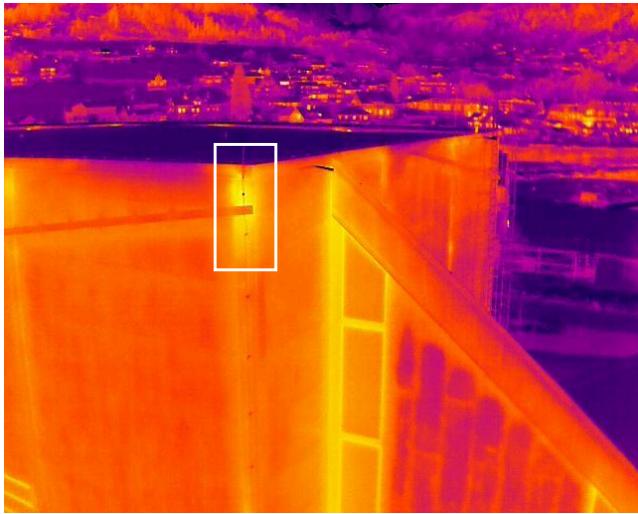
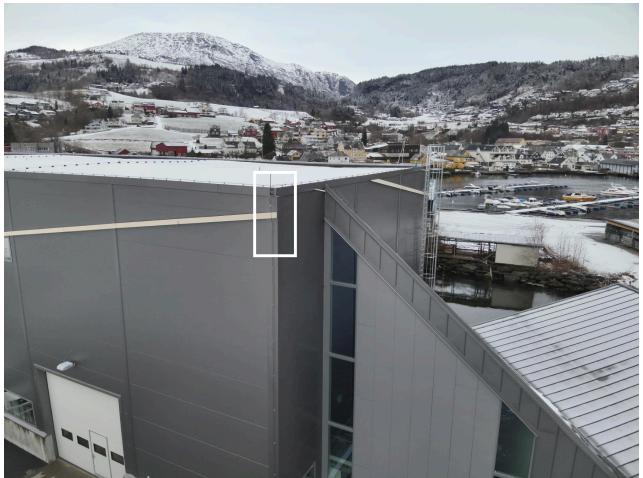
Deviation 004 – Facade

RPL 2

A clear thermal bridge is evident in the marked area of the thermal image, although it is not visually observable. This indicates a potential issue with heat loss in the facade. Additionally, there is poor sealing observed at the outer corner, which may lead to condensation within the construction. The extent of the issue suggests that it could affect the overall thermal performance of the building. The thermal imaging highlights the discrepancy in temperature, indicating a significant deviation from expected thermal behavior. This could compromise the integrity of the building envelope over time.

The likely cause of the thermal bridge is inadequate insulation or a break in the thermal barrier at the marked location. Poor sealing at the outer corner exacerbates this issue, increasing the risk of moisture ingress and potential condensation within the structure. If left unaddressed, these conditions could lead to mold growth and deterioration of building materials.

kWh: 270 CO₂ (kg): 53,7

Dismantle the external cladding to access the affected area. Repair the sealing at the outer corner to prevent further moisture intrusion. Ensure proper insulation is reinstated to mitigate thermal bridging.

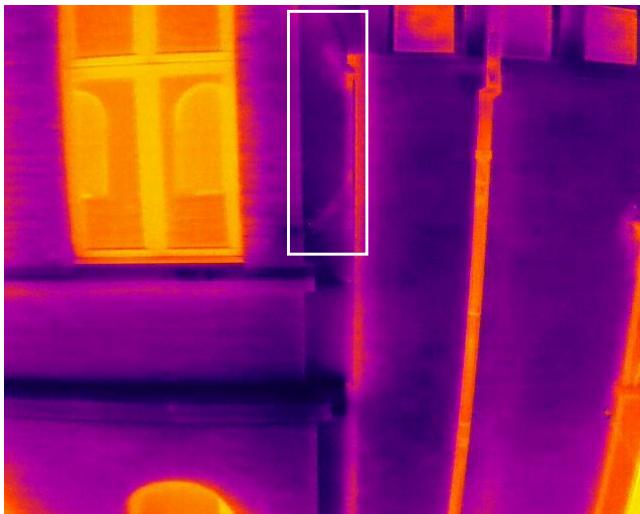
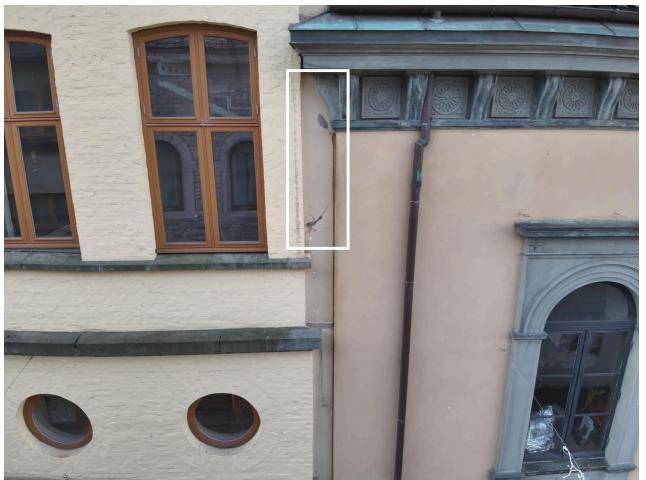
Deviation 005 – Facade

RPL 3

Cracking has been observed in the facade, which is evident both thermally and visually. The cracks appear to be distributed across various sections of the facade, indicating a potential structural issue. The extent of the cracking suggests that it may be significant, warranting further investigation. The visual evidence shows irregular patterns of cracking that could compromise the integrity of the building. Thermal imaging may reveal temperature differentials associated with the cracks, suggesting underlying issues. The facade's condition raises concerns about its long-term durability and performance.

The exact cause of the cracking is uncertain, but it is likely related to settlement damage. Such damage can occur due to ground movement or inadequate foundation support. If left unaddressed, these cracks could lead to further structural deterioration and potential safety hazards.

Repairs should be conducted promptly to address the cracking in the facade. A thorough assessment of the foundation and surrounding soil conditions is recommended. Preventative measures should be implemented to mitigate future settlement issues.

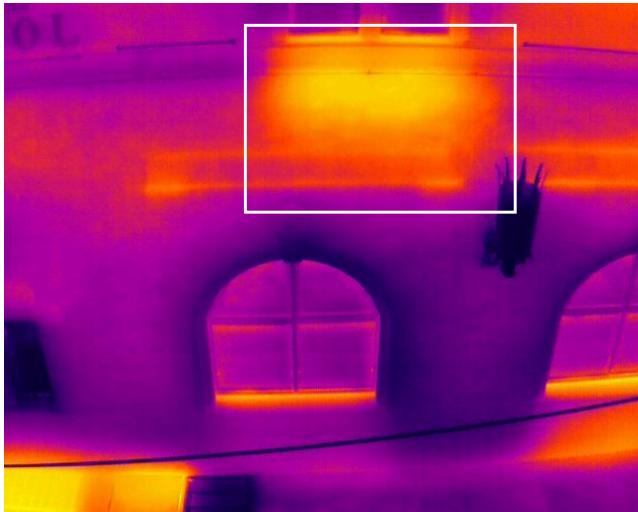
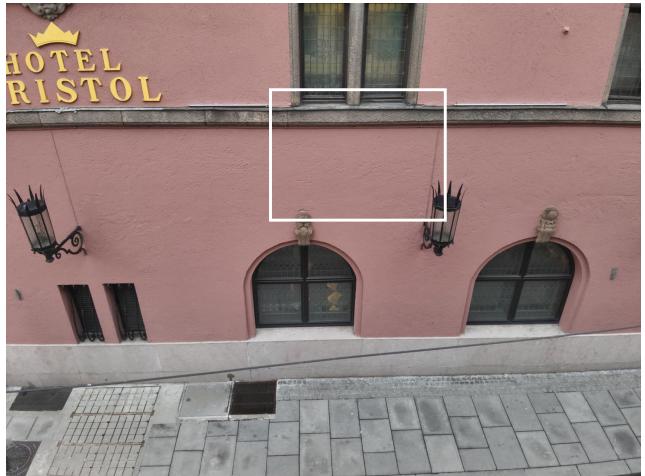
Deviation 006 – Facade

RPL 2

Significant thermal bridging is observed at the base of the window, as evidenced by the marked thermal image indicating heat loss. This issue is primarily located where the window frame meets the adjacent construction. The extent of the thermal bridging suggests a considerable energy loss, which may impact the overall energy efficiency of the building. The insulation layer between the window frame and the adjoining structure is either limited or entirely absent, exacerbating the thermal inefficiency. This condition can lead to increased heating costs and potential discomfort for occupants due to drafts.

The most likely cause of this issue is inadequate or missing insulation at the junction between the window frame and the surrounding construction. This lack of proper insulation can result in significant energy loss and may lead to condensation issues, which could further damage the building fabric over time. Uncertainty exists regarding the full extent of the insulation deficiency without further investigation.

kWh: 1400 CO₂ (kg): 279

Repair the seal under the window to improve insulation. Ensure that proper insulation is installed between the window frame and adjacent construction. Regularly inspect and maintain window seals to prevent future issues.

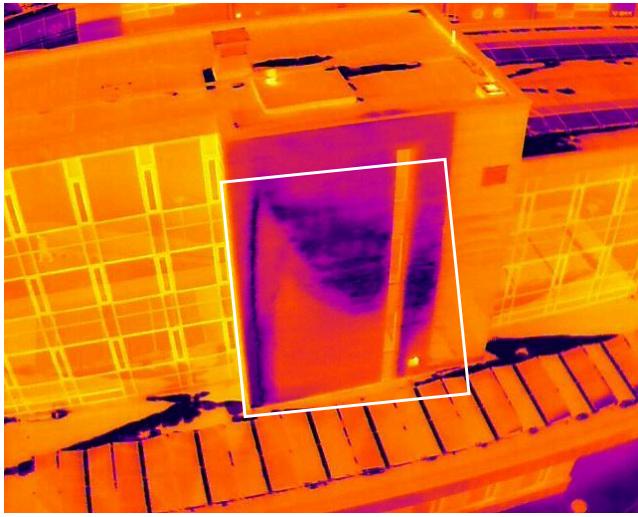
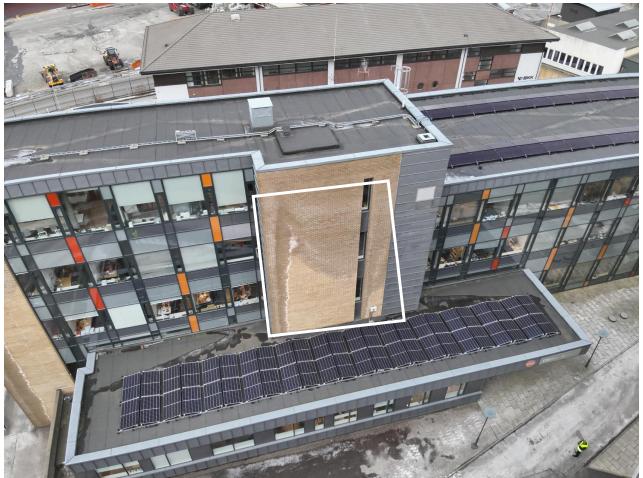
Deviation 007 – Facade

RPL 3

Significant moisture retention has been observed in the construction, which is evident as darker areas in the attached thermal image. This moisture issue appears to be widespread, affecting various sections of the facade. The extent of the moisture infiltration suggests a potential underlying problem that requires further investigation. The affected areas are likely to compromise the integrity of the building materials and may lead to further deterioration if not addressed promptly. The presence of moisture can also create an environment conducive to mold growth, posing health risks to occupants. A thorough assessment is necessary to determine the full extent of the damage and the specific locations impacted.

The most likely cause of the moisture retention is a leak from the roof or parapet, which has allowed water to infiltrate the facade. This situation poses risks such as structural damage, mold growth, and potential health hazards for building occupants. The uncertainty regarding the exact source of the leak necessitates a detailed investigation to confirm the cause and extent of the moisture problem.

Conduct a thorough inspection to identify the source of the leak. Implement necessary repairs to the roof or parapet to prevent further moisture intrusion. Monitor the affected areas for any signs of recurring moisture issues.

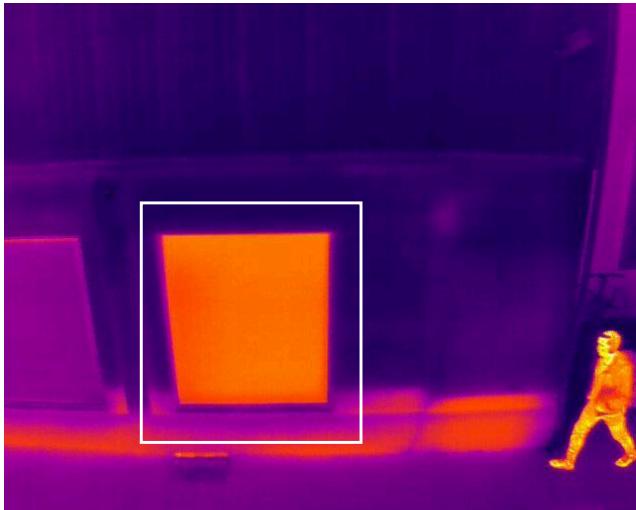
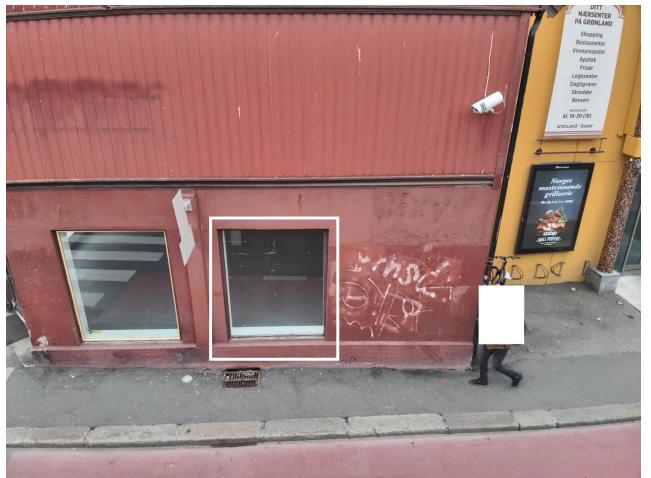
Deviation 008 – Facade

RPL 2

The marked window exhibits clear signs of puncturing, which is visible upon inspection. This defect is characterized by the presence of air leakage between the glass layers, leading to a compromised thermal performance of the window. The issue is localized to the specific window indicated, and it affects the overall energy efficiency of the facade. The visual evidence suggests that the integrity of the window's seal has been breached, which may also lead to condensation or fogging between the panes. This condition can significantly impact the comfort and energy consumption of the building. The extent of the problem appears to be limited to this particular window, but it may indicate broader issues if not addressed promptly.

The primary cause of the observed issue is likely due to a failure in the sealant or the glass itself, resulting in puncturing. This failure can lead to increased air infiltration, which negatively affects the window's U-value and overall energy efficiency. If left unaddressed, this could result in further deterioration of the window and increased energy costs for heating or cooling. There is some uncertainty regarding whether the damage is isolated or indicative of a more systemic problem within the facade.

kWh: 1150 CO₂ (kg): 229

The window should be repaired or replaced to restore its integrity and thermal performance. Regular inspections of window seals and glass should be conducted to prevent similar issues in the future.

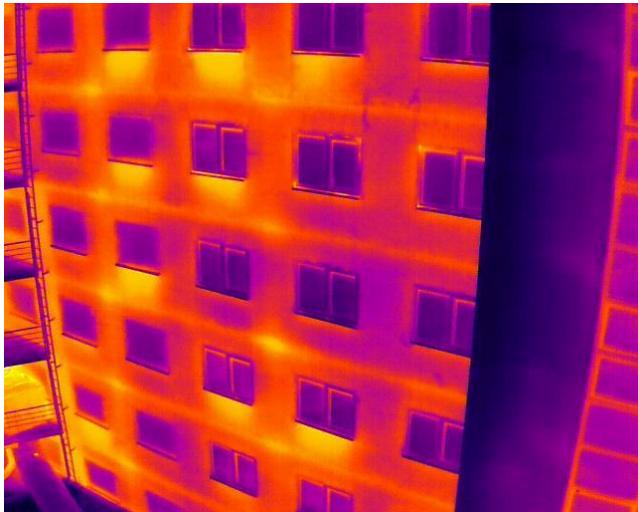
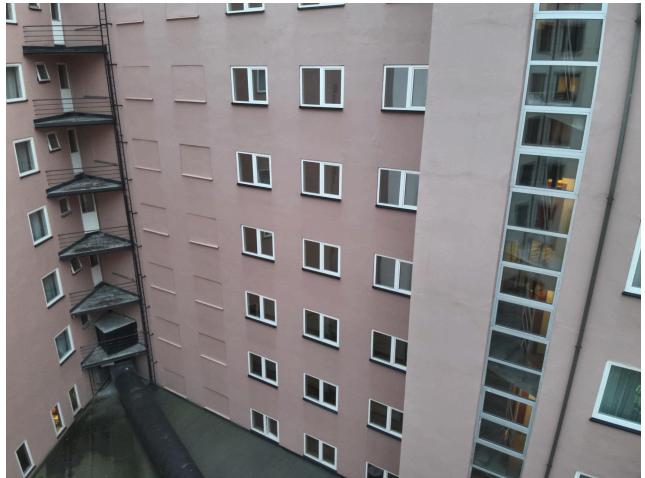
Deviation 009 – Facade

RPL 2

Significant heat loss is observed from all windows in the marked facade. The heat loss is primarily prominent at the bottom of the windows. This condition leads to considerable energy loss and condensation, which adversely affects the condition of both the windows and the surrounding construction. The issue is particularly noticeable in the lower sections of the window frames. Visual inspection reveals gaps and potential signs of moisture accumulation. The extent of the problem suggests a systemic issue with the window installations.

The likely cause of the heat loss is poor or missing sealing and insulation between the bottom frame of the windows and the surrounding construction. This deficiency can lead to increased energy costs and potential structural damage over time due to moisture infiltration and condensation.

kWh: 18300 CO₂ (kg): 3641

Improve the sealing by adding insulation or foam between the window frames. Ensure that all gaps are properly filled to prevent future heat loss. Regular maintenance checks should be implemented to monitor the condition of the seals.
